NPDES Compliance Inspection Report

Name and Location of Facility Inspected (For industrial users discharging to POTW, also include POTW name and NPDES permit number)		Entry Time /Date	Permit Effective Date
Cedar Chemical Corporation 49 Phillips Road 311 Highway 242 South, Helen, Arkansas Phillips County		1000 / April 21, 2004	June 1, 2002
		Exit Time/Date	Permit Expiration Date
		1045/ April 21, 2004	May 31, 2007
Name(s) of On-Site Representative(s)/Title(s)/Phone and Fax Number(s)		Other Facility Data	
Gary Hill / operator			
Name, Address of Responsible Official/Title/Phone and Fax Number		Sample Location	
Mike Bates/ Hazardous Waste Division Chief/ 501-862-0831 Arkansas Dept. of Environmental Quality 8001 National Drive/ Post Office Box 8913/ Little Rock, Arkansas 72219-8913		N-34-31-04.9 W-90-39-10.2	
		Contacted Yes <input checked="" type="checkbox"/> No <input type="checkbox"/>

Name and Location of Facility Inspected (For industrial users discharging to POTW, also include POTW name and NPDES permit number)		Entry Time /Date		Permit Effective Date	
Cedar Chemical Corporation 49 Phillips Road 311 Highway 242 South Helena, Arkansas 72342 Phillips County		0915 / November 9, 200

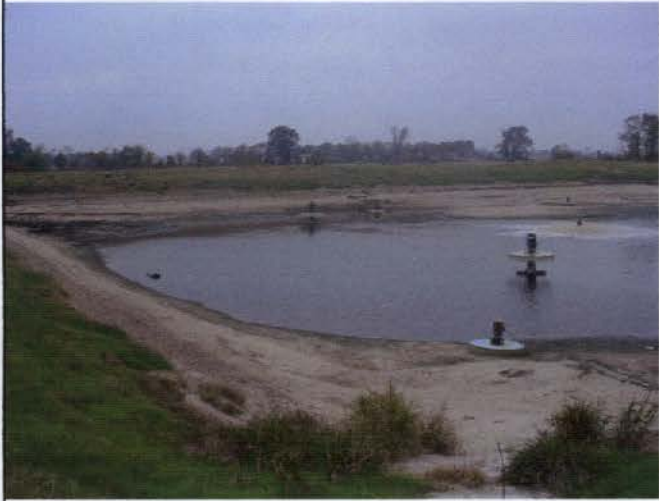
Location:	<i>Cedar Chemical, 49 Phillips Road 311, Helena, Arkansas 72342</i>						
Photographer:	<i>Steven L. Henderson</i>				Witness:	<i>Gary Hill, Operator</i>	
Photo #	<i>1</i>	Of	<i>6</i>		Date:	<i>11/09/05</i>	Time: <i>11:24 a.m.</i>
Description:	<i>Primary Pond</i>

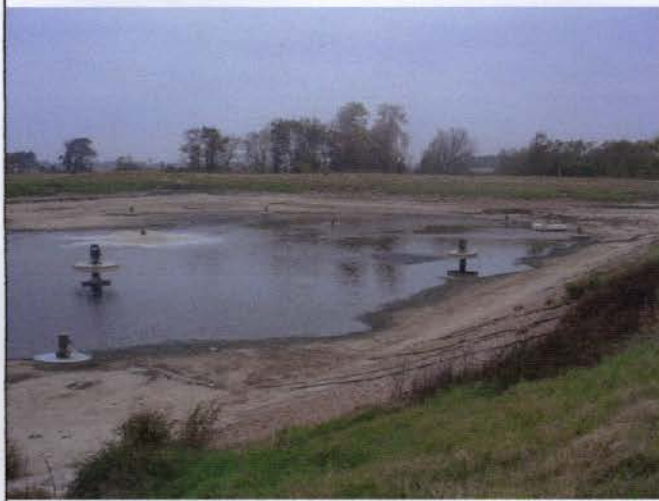
Photographer:	<i>Steven L. Henderson</i>				Witness:	<i>Gary Hill, Operator</i>	
Photo #	<i>2</i>	Of	<i>6</i>		Date:	<i>11/09/05</i>	Time: <i>11:24 a.m.</i>
Description:	<i>Primary Pond</i>

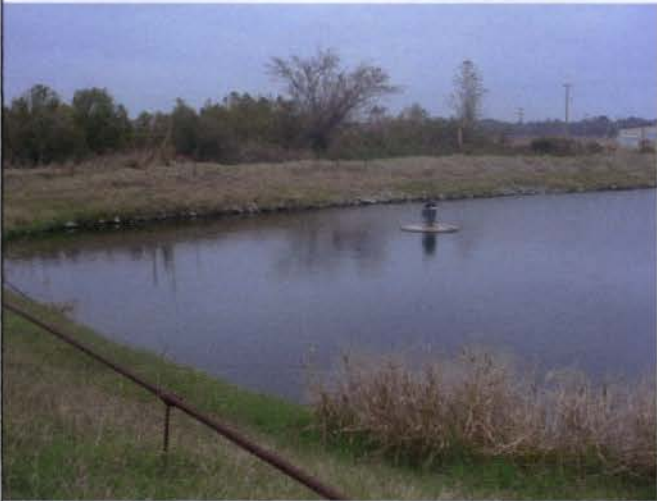
Location:	<i>Cedar Chemical, 49 Phillips Road 311, Helena, Arkansas 72342</i>					
Photographer:	<i>Steven L. Henderson</i>			Witness:	<i>Gary Hill, Operator</i>	
Photo #	<i>3</i>	Of	<i>6</i>	Date:	<i>11/09/05</i>	Time: <i>11:25 a.m.</i>

Description:	<i>Secondary Pond</i>

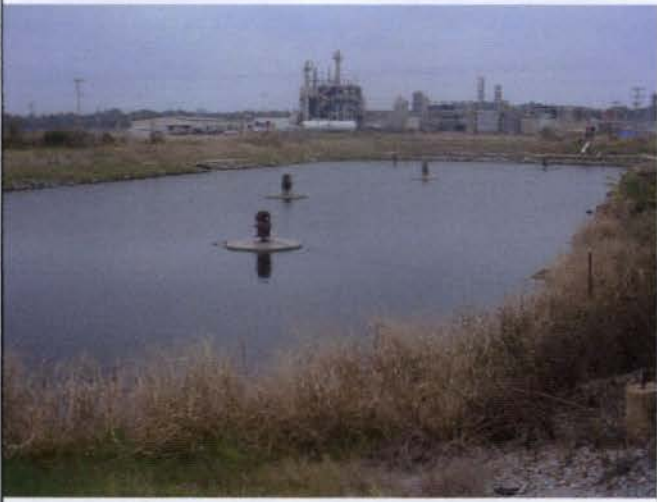
Photographer:	<i>Steven L. Henderson</i>			Witness:	<i>Gary Hill, Operator</i>	
Photo #	<i>4</i>	Of	<i>6</i>	Date:	<i>11/09/05</i>	Time: <i>11:25 a.m.</i>

Description:	<i>Secondary Pond</i>

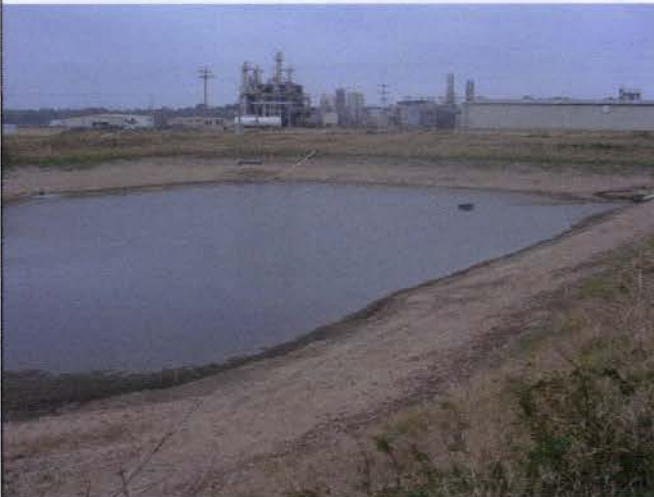
Location:		<i>Cedar Chemical, 49 Phillips Road 242 South, Helena, Arkansas 72342</i>						
Photographer:		<i>Steven L. Henderson</i>			Witness:		<i>Gary Hill, Operator</i>	
Photo #	<i>5</i>	Of	<i>6</i>		Date:	<i>11/09/05</i>	Time:	<i>11:24 a.m.</i>
Description:		<i>Finishing Pond</i>
